Study Findings:
Sources of
drilling error

AUSTRALIAN SURVEY STUDY: BOOM

LOCATION:	Australia
YEAR:	2019 - 2020
INDUSTRY:	Underground Mining, Long-Hole Stopping
CLIENT:	Multiple
FOCUS:	Production Drilling
DRILL TYPE:	Boom
SOLUTION:	Production Optimiser

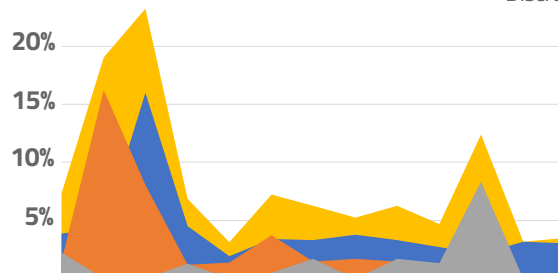
All Holes	Collar Error Avg	Alignment Error Avg	In-Hole Error Avg	Total (Toe) Deviation Avg*
13 Sites	1,067	0.6% ■	3.5% ■	2.3% ■	6.2% ■

*Discrepancies in 'Total' due to rounding errors

Inaccurate Drilling: Across thirteen sites, average toe deviation was **6.2%**. Over the average hole length (15.4m), this equates to an error of **1.0m**. Average toe deviation is therefore well outside industry 'best practice'.

Sources of Error: The majority of toe deviation (**56%**) was due to alignment error – indicating flaws in the existing process for setting up the drill were primarily to blame for overall inaccuracy.

Around 9% of the error at the toe was due to collaring error and 35% due to in-hole deviation.

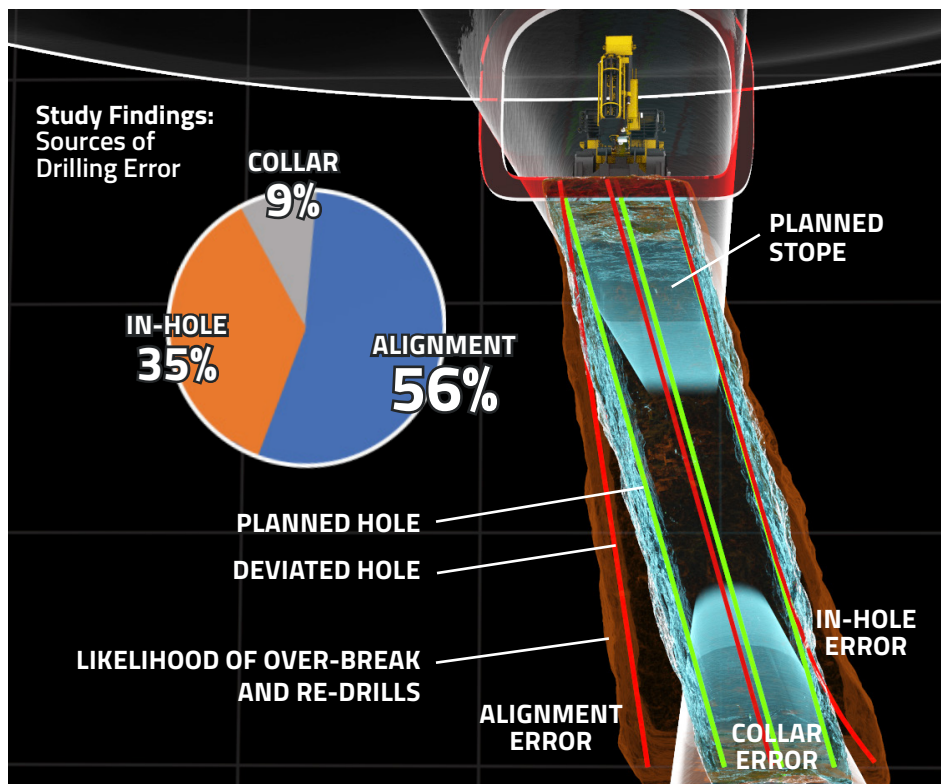
By Site, w/Breakdown:

- Total Average Deviation
- In-Hole Contribution
- Collar Contribution
- Alignment Contribution

Inconsistent Drilling: The stand dev. in alignment error was 3.3% with the Boom, indicating highly variable set up accuracy.
