AUSTRALIAN BLAST-HOLE SURVEY STUDY

Down-hole surveys were conducted across 17 Australian underground hard rock operations. The results have been analysed to better understand typical drilling accuracy and the factors that result in blast-hole deviation. The data was further broken down by rig type (Boom and Horseshoe).

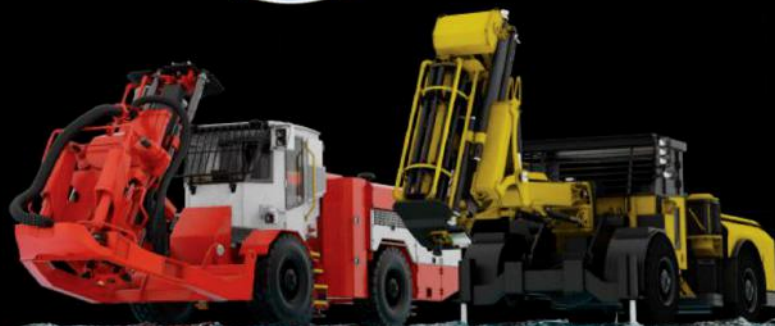
Study Findings:
Sources of drilling error

There are three factors that contribute to blast-hole deviation; **collar** error (due to collar location error), **in-hole** deviation (due to ground conditions and operator skill/judgment during drilling) and **alignment** error.

Sources of Error: The majority of toe deviation (60%) was due to alignment error - indicating flaws in the existing process for setting up the drill were primarily to blame for overall inaccuracy. Around 4% of the error at the toe was due to collaring error and 36% due to in-hole deviation.

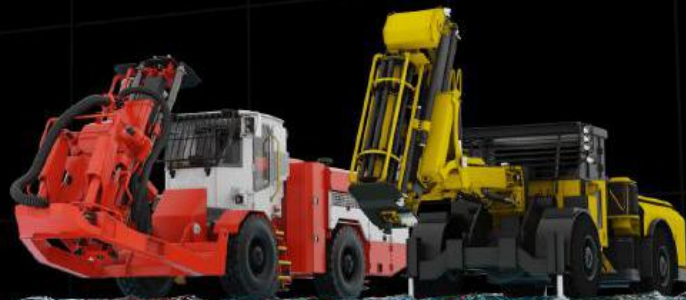
EXISTING RIG SETUP PROCESS, NOT RIG TYPE, IS THE PRIMARY CAUSE OF POOR DRILLING:

Drill Type	All Holes	Collar Error Avg	Alignment Error avg	In-Hole Error Avg	Total (Toe) Deviation Avg*
Boom	0.65%	3.5%	3.3%	2.4%	6.2%
Horseshoe	0.05%	3.0%	2.1%	2.4%	5.4%
Average	0.3%	3.3%	2.27%	2.4%	5.8%

Inconsistent Drilling: The stand dev. in alignment error was 2.7% across drill types, indicating highly variable set up accuracy irrespective of rig type.
