## AUSTRALIAN BLAST-HOLE SURVEY STUDY

Down-hole surveys were conducted across 17 Australian underground hard rock operations. The results have been analysed to better understand typical drilling accuracy and the factors that result in blast-hole deviation. The data was further broken down by rig type (Boom and Horse-Shoe).

## BLAST-HOLE DEVIATION EXPLAINED FINDINGS ACROSS ALL 17 SITES

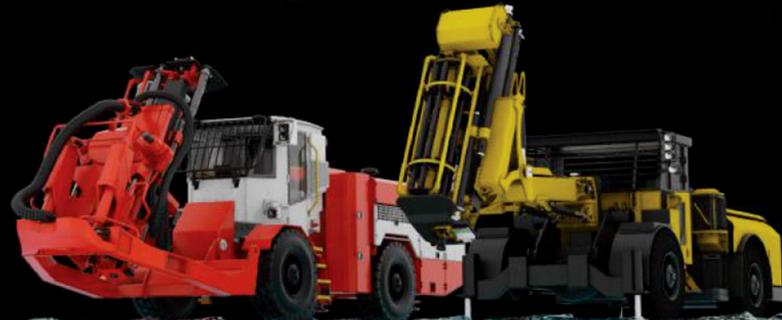
**Study Findings:**  
Sources of drilling error

There are three factors that contribute to blast-hole deviation; **collar** error (due to collar location error), **in-hole** deviation (due to ground conditions and operator skill/judgment during drilling) and **alignment** error.

**Sources of Error:** The majority of toe deviation (60%) was due to alignment error - indicating flaws in the existing process for setting up the drill were primarily to blame for overall inaccuracy. Around 4% of the error at the toe was due to collaring error and 36% due to in-hole deviation.

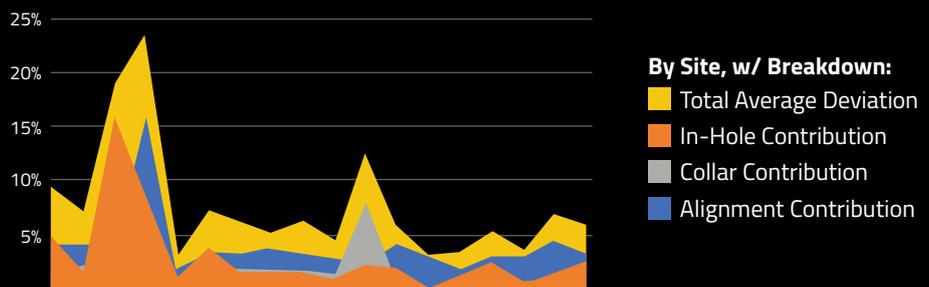
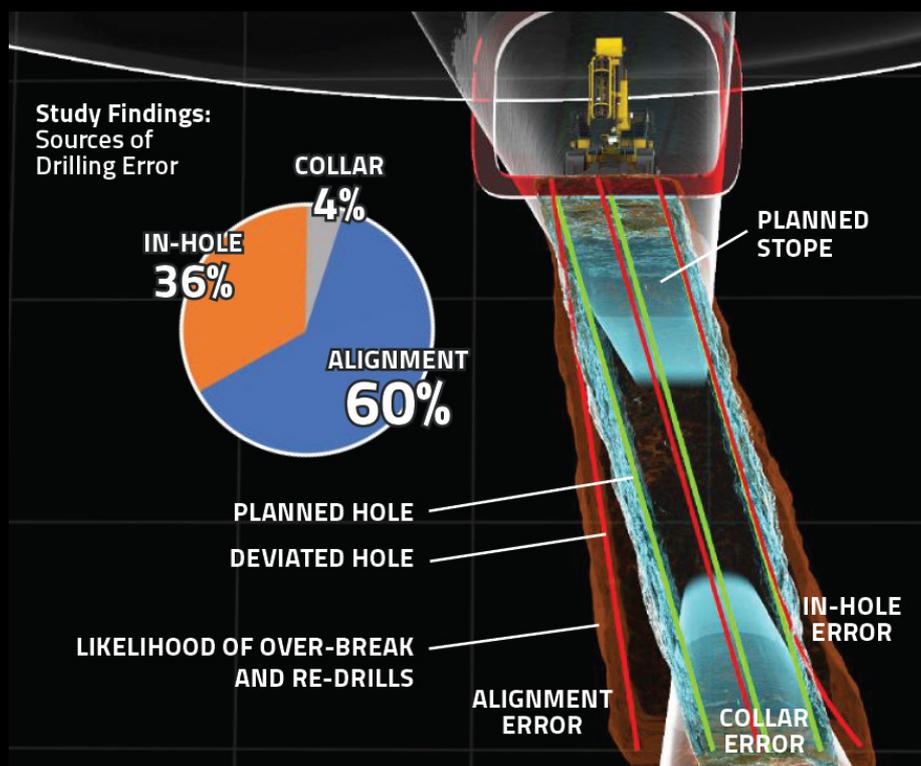
**INACCURATE: 5.8% AVG HOLE DEVIATION ACROSS ALL 17 SITES**

**Inaccurate Drilling:** Across the 17 mines, average toe deviation was 5.8%. Over the average hole length (24m), this equates to an error of 1.4m. Average toe deviation is therefore well outside industry 'best practice'.

All Holes	Collar Error Avg	Alignment Error avg	In-Hole Error Avg	Total (Toe) Deviation Avg*
All 17 sites	2,408	0.3%	3.3%	2.4%	5.8%

▄▄ Average deviation at the toe across all 17 sites was **5.8%** (1.4m over a 24m hole) - well outside 'best practice'.

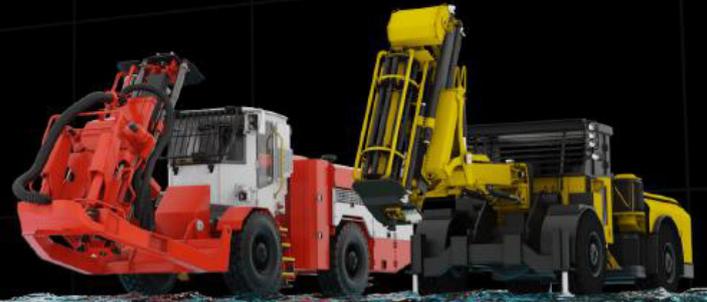
**EXISTING RIG SETUP PROCESS, NOT RIG TYPE, IS THE PRIMARY CAUSE OF POOR DRILLING:**

**Inconsistent Drilling:** The stand dev. in alignment error was 2.7% across drill types, indicating highly variable set up accuracy irrespective of rig type.

Drill Type	All Holes	Collar Error Avg	Alignment Error avg	In-Hole Error Avg	Total (Toe) Deviation Avg*
Boom	0.65%	3.5%	3.3%	2.4%	6.2%
Horse-Shoe	0.05%	3.0%	2.1%	2.4%	5.4%
<b>Average</b>	<b>0.3%</b>	<b>3.3%</b>	<b>2.27%</b>	<b>2.4%</b>	<b>5.8%</b>
